Manhole Inspection Summary

Manhole # S41I__044MH

Location Address: **1300 gough st**

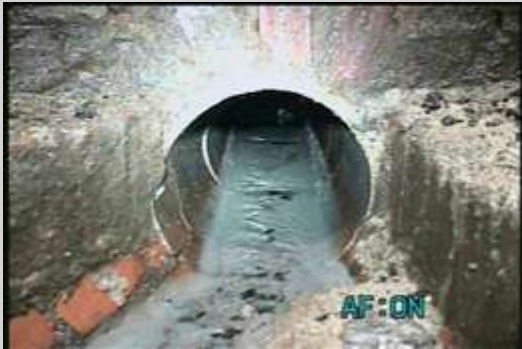
12 O'Clock Outflow

8 in. Circular Gravity Sewer
Pipe Out @ 12 O'Clock

Deposits: ☒ None ☐ Mud ☐ Sludge ☐ Debris ☐ Grease

Infiltration: **None** Pipe Seal Cond: **Unknown**

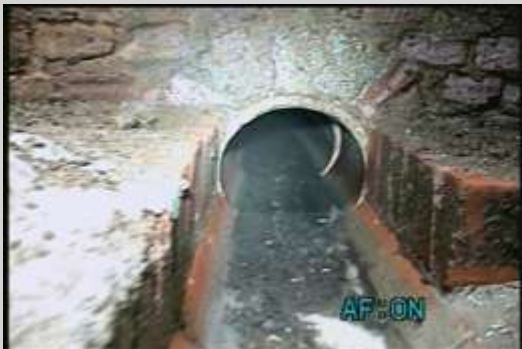
6 O'Clock Inflow

8 in. Circular Gravity Sewer
Pipe In @ 6 O'Clock

Deposits: ☒ None ☐ Mud ☐ Sludge ☐ Debris ☐ Grease

Infiltration: **None** Pipe Seal Cond: **Unknown**

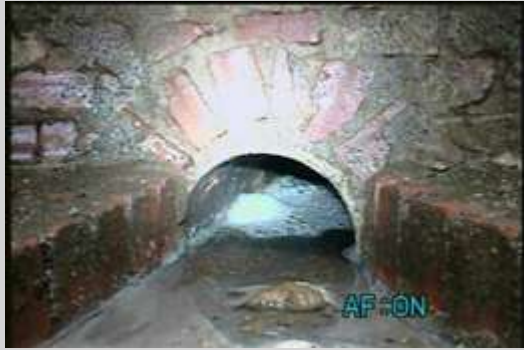
9 O'Clock Inflow

8 in. Circular Gravity Sewer

Pipe In @ 9 O'Clock

Infiltration: **None** Pipe Seal Cond: **Unknown**
